LRC Building, Llysfasi

Pre-Planning Structural Inspection Report

RP-16024-001

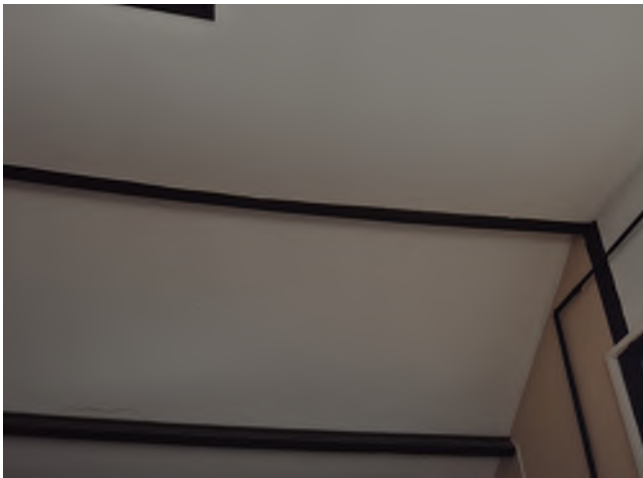
Observation 1:

- *Visible deflection of existing roof purlins.*
- *Undersized roof structure causing deflection.*

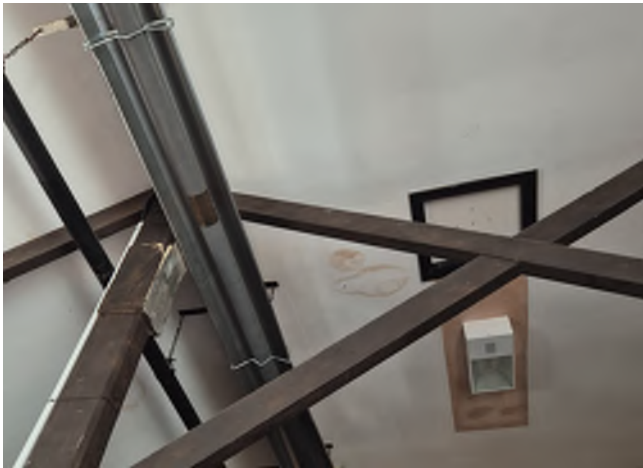
Observation 2:

- *Damp stains on ceiling, sign of leaking roof.*
- *Remedial works previously carried out on existing truss.*

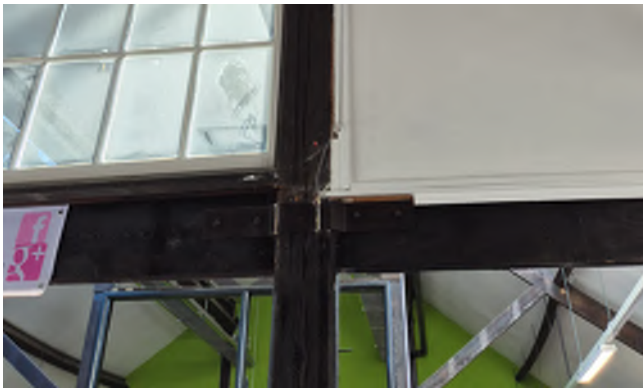
Observation 3:

- *Signs of movement at timber joint, remedial works carried out to tie timbers together using steel bracket.*

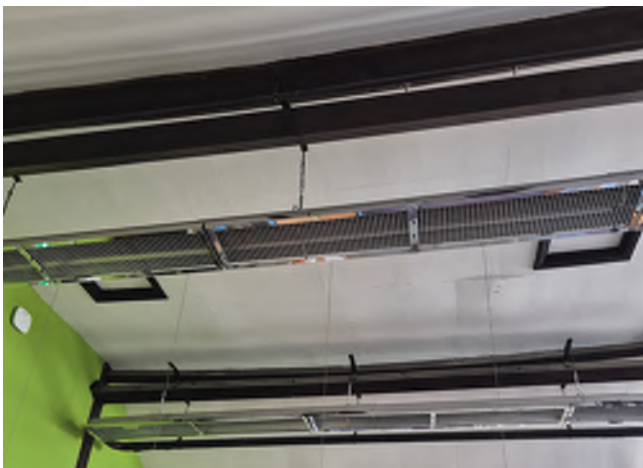
Observation 4:

- *Visible deflection and twisting to timber purlins.*
- *Undersized purlins causing deflection.*

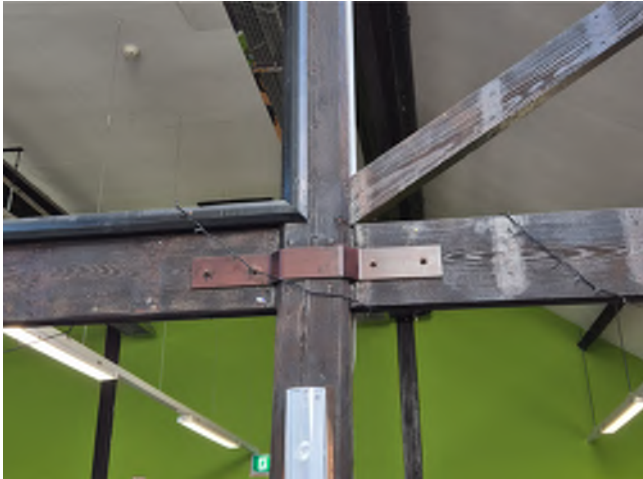
Observation 5:

- *Signs of movement at timber joint, remedial works carried out to tie timbers together using steel bracket.*

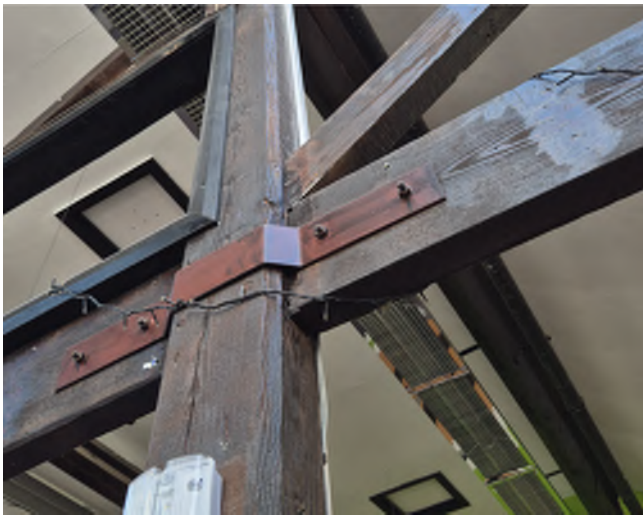
Observation 6:

- *Signs of movement at timber joint, remedial works carried out to tie timbers together using steel bracket.*

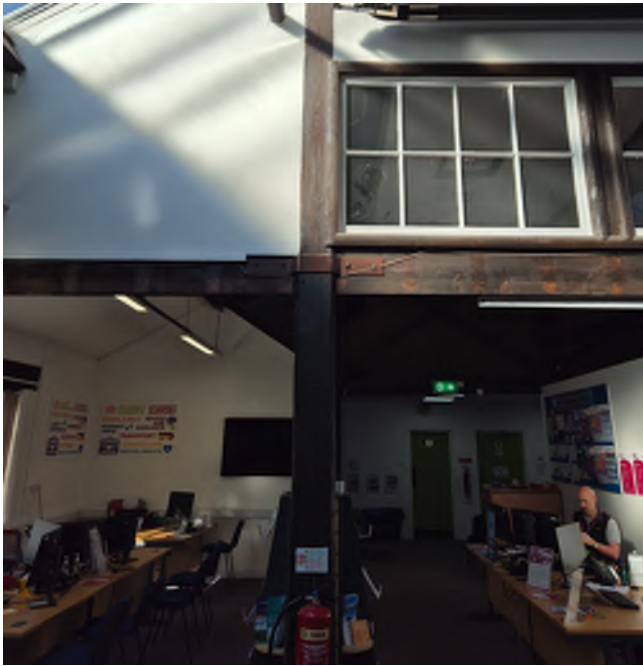
Observation 7:

- *Signs of movement at timber joint, remedial works carried out to tie timbers together using steel bracket.*
- *Signs of lean to timber upright post.*

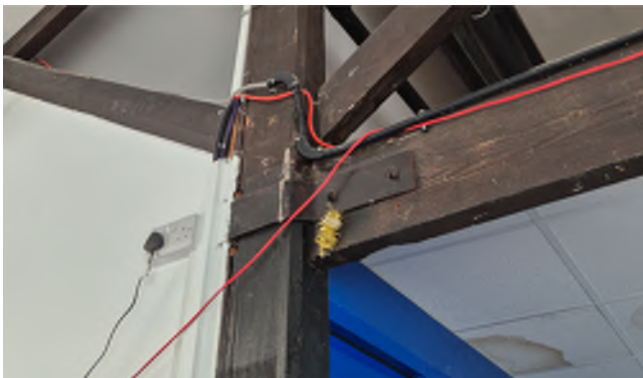
Observation 8:

- *Signs of movement at timber joint, remedial works carried out to tie timbers together using steel bracket.*
- *Section loss of timber upright post.*
- *Upright timber splitting.*

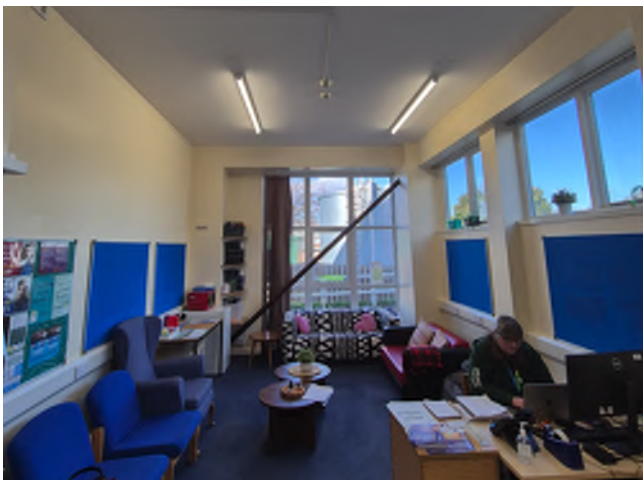
Observation 9:

- *Bracing appears to be installed as a remedial solution to building movement.*

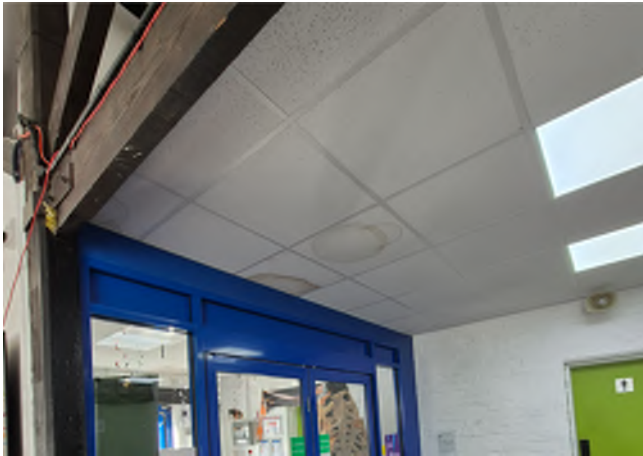
Observation 10:

- *Damp stains on ceiling, sign of leaking roof.*

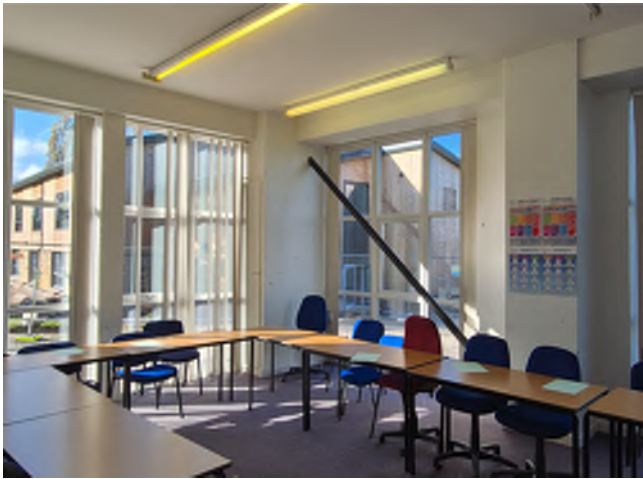
Observation 11:

- *Bracing appears to be installed as a remedial solution to building movement.*

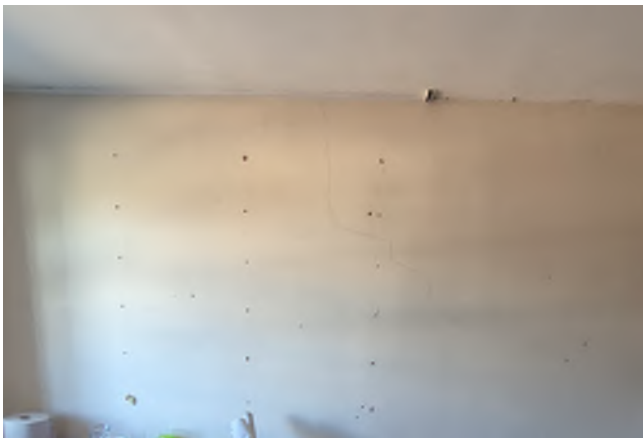
Observation 12:

- *Cracking to wall, signs of movement.*

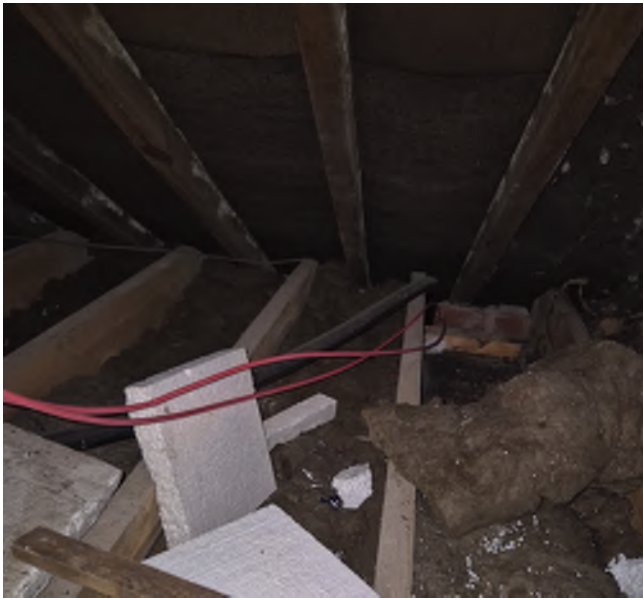
Observation 13:

- *Timber rafters appear undersized, this may contribute to the roof deflection.*

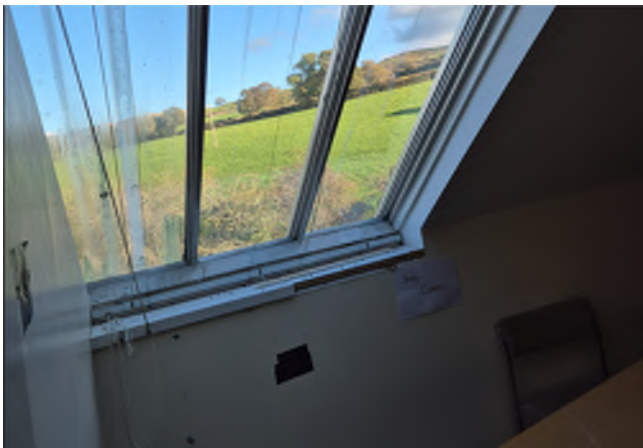
Observation 14:

- *Mould and vegetation on the windows, signs of water ingress.*

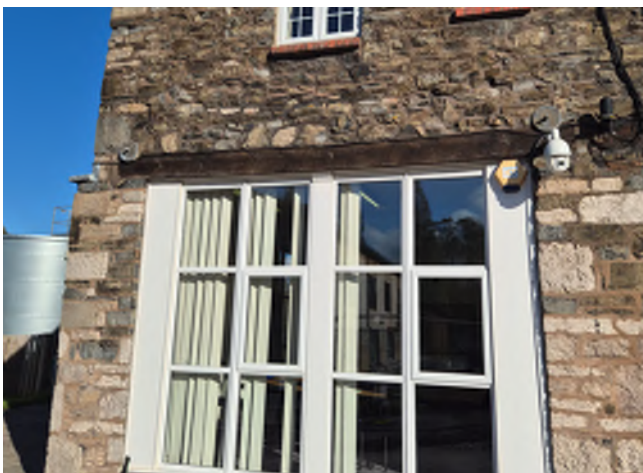
Observation 15:

- *Deflection of existing timber lintel over window.*
- *Parrass plates installed to tie and remedy movement to the building.*

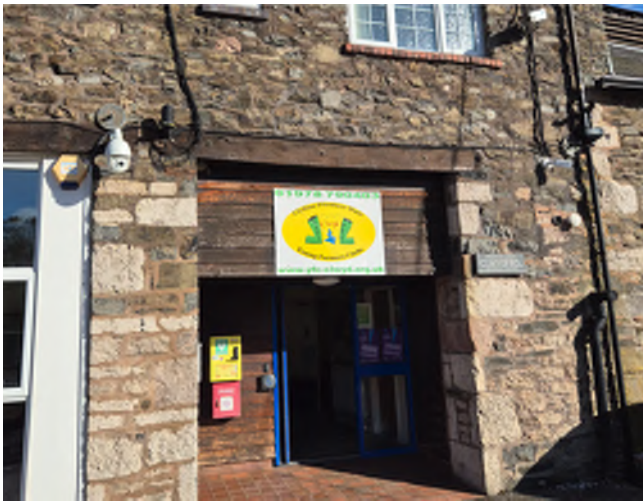
Observation 16:

- *Deflection of existing timber lintel over window.*
- *Pattress plates installed to tie and remedy movement to the building.*

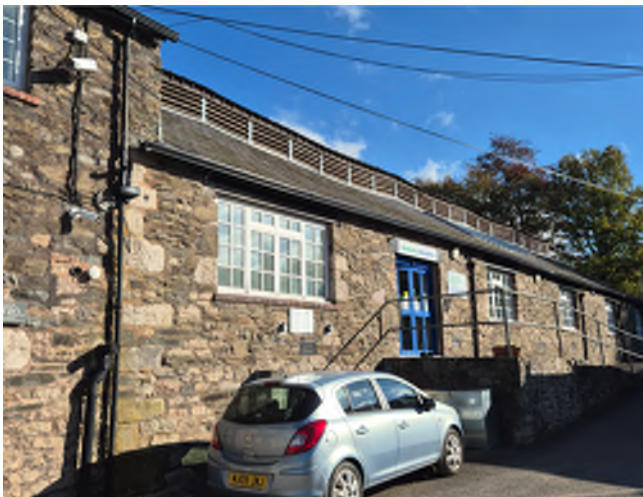
Observation 17:

- *Visible deflection to existing roof.*

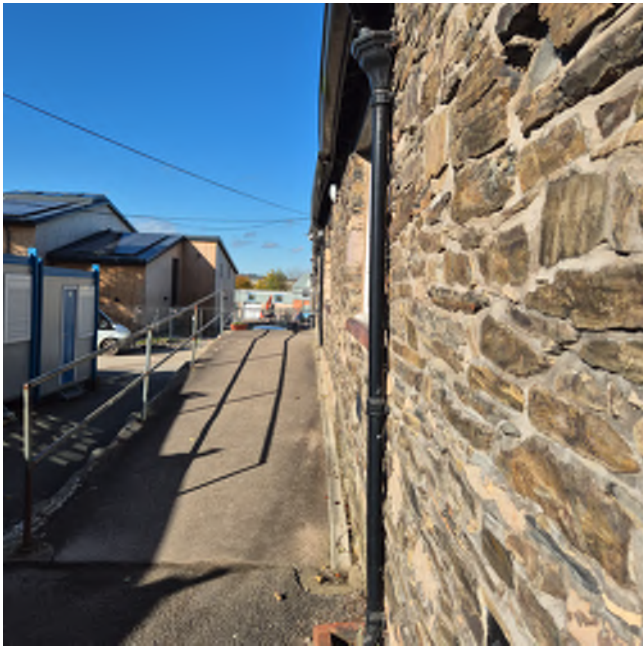
Observation 18:

- Slight visible lean to existing wall.

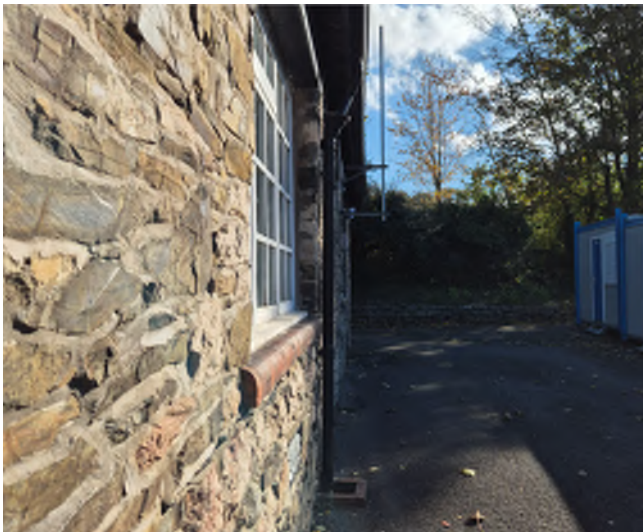
Observation 19:

- Slight visible lean to existing wall.

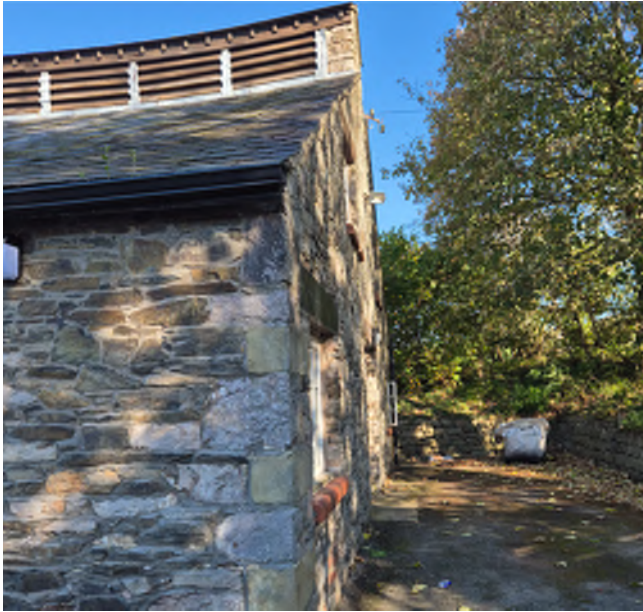
Observation 20:

- Visible defined deflection to existing roof.
- Lean to existing gable.
- Pronounced leaning to existing stonework built up to the ridge.

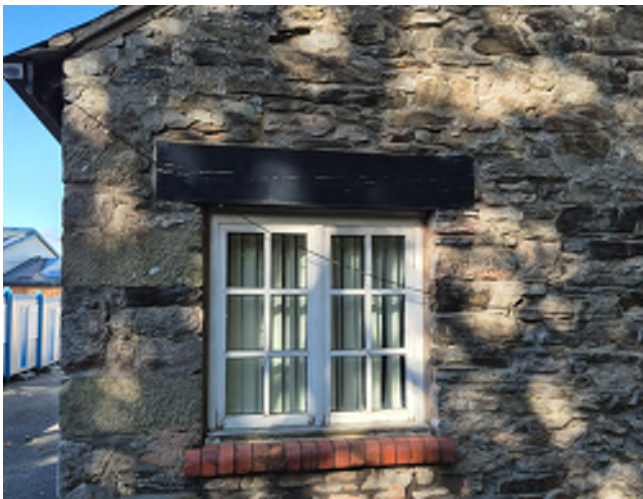
Observation 21:

- Deflection of existing timber lintel over window.

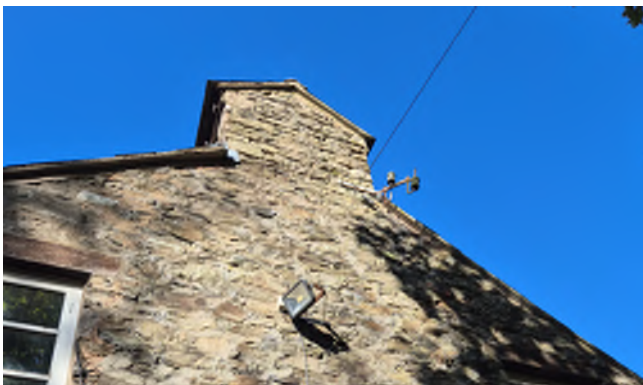
Observation 22:

- Visible lean to existing wall.

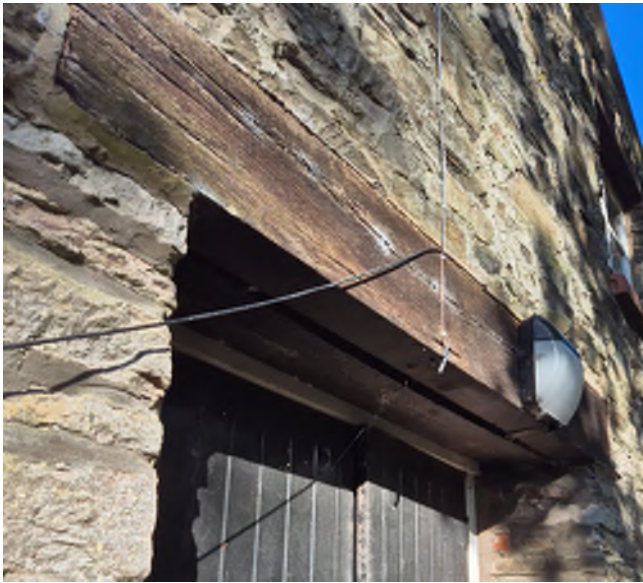
Observation 23:

- *Deflection of existing timber lintel over window.*
- *Splitting to timber lintel.*

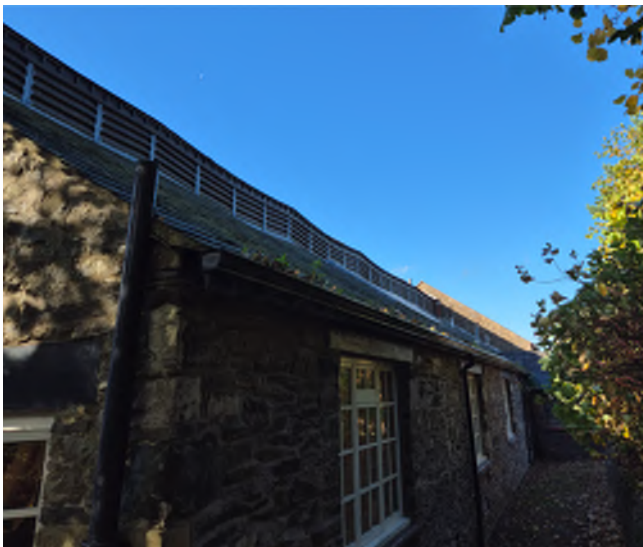
Observation 24:

- *Visible defined deflection to existing roof.*

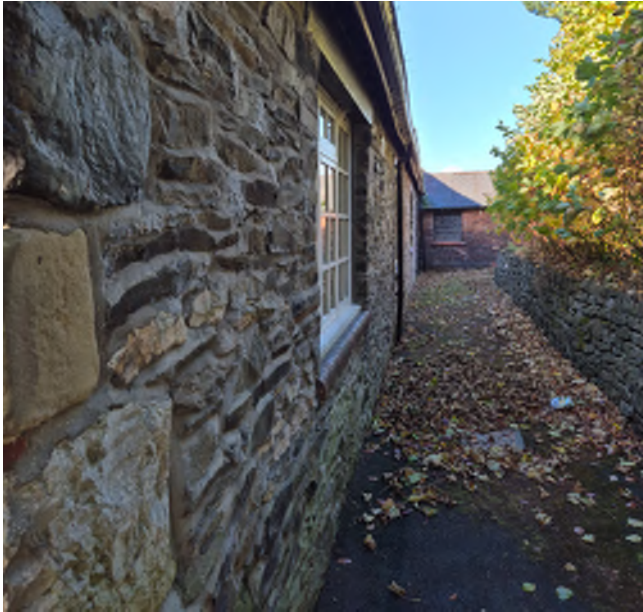
Observation 25:

- *Slight visible lean to existing wall.*

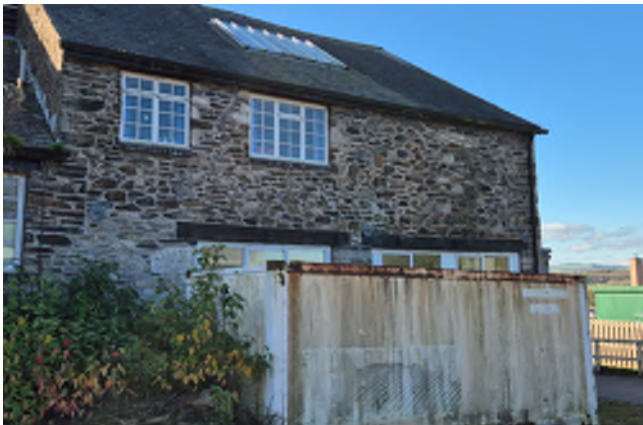
Observation 26:

- *Visible defined deflection to existing roof.*
- *Deflection of existing timber lintel over window.*
- *Pattress plates installed as a sign of movement to the building.*

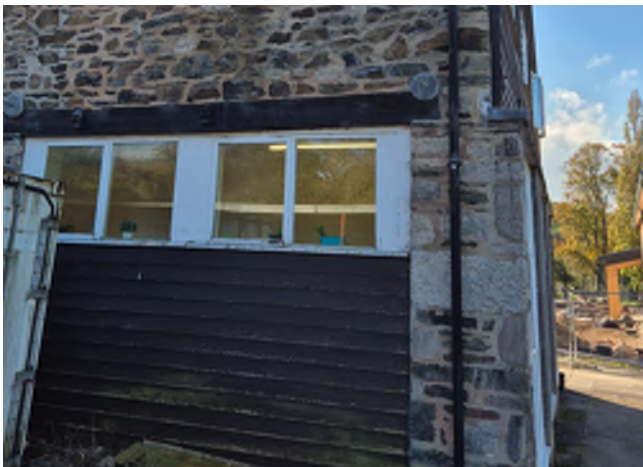
Observation 27:

- *Slight visible lean to existing wall.*
- *Deflection of existing timber lintel over window.*
- *Pattress plates installed to tie and remedy movement to the building..*

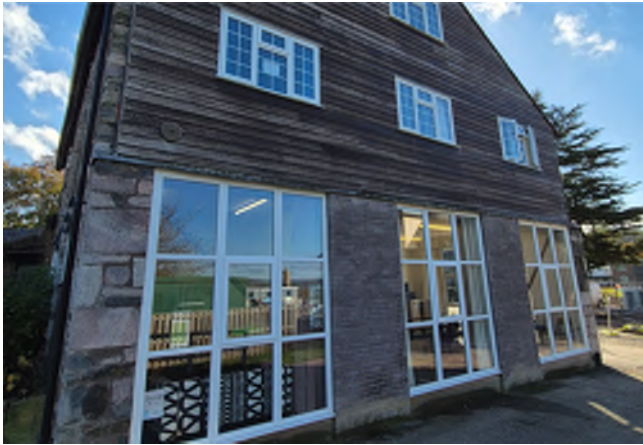
Observation 28:

- *Slight visible lean to existing wall.*
- *Pattress plates installed to tie and remedy movement to the building.*

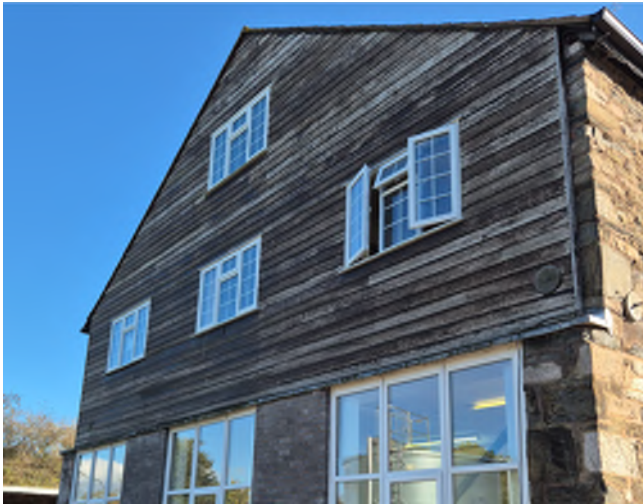
Observation 29:

- *Slight visible lean to existing wall.*
- *Pattress plates installed to tie and remedy movement to the building.*
