COLEG CAMBRIA, LLYSFASI ACCOMMODATION BLOCK

PRELIMINARY ROOST ASSESSMENT, NESTING BIRD ASSESSMENT AND EMERGENCE SURVEYS

Report Ref: EE.4269.24.LB

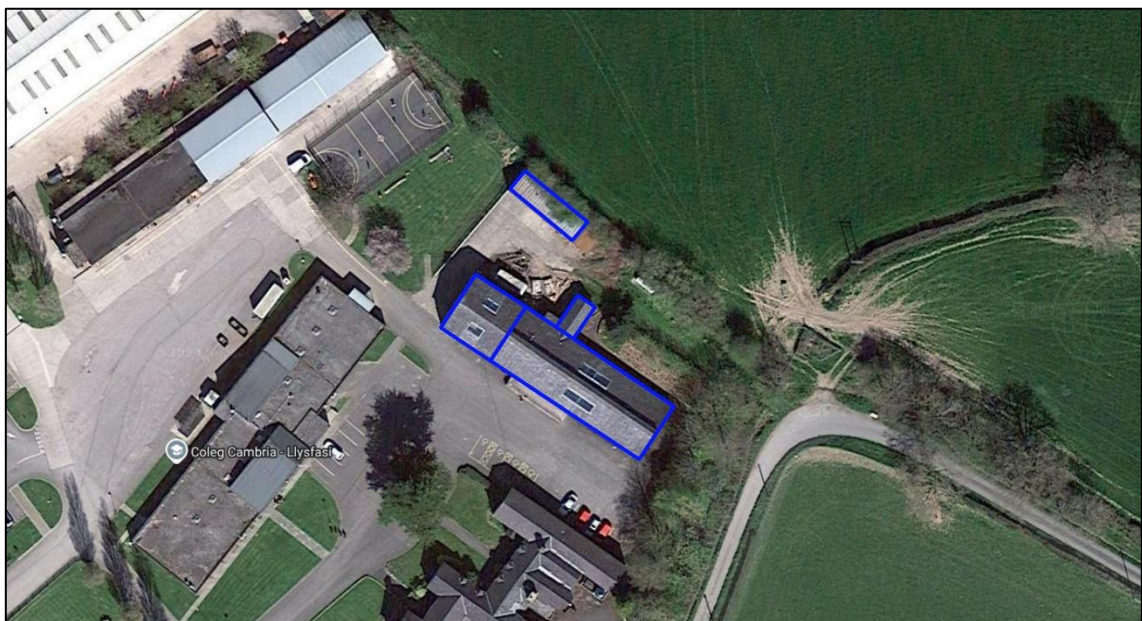
FIGURE 2.1. THE SURVEYED BUILDINGS ARE SHOWN IN BLUE. BASE IMAGE ©GOOGLE 2024

2.1.1 The survey area comprised the Learning Resource Centre, situated at the southern end of the campus, which had a three-storey section on the western elevation, a single storey section on the eastern elevation and a small single storey outbuilding on the northern elevation. To the north of this building, was a large corrugated metal shed, which was open on the southern side. Other habitats within the immediate area, included an area of amenity grassland, a multi-use games area (MUGA), and trees and scrub along the northern boundary including hawthorn, holly, hazel and elder. A plan of the surveyed buildings is shown in Figure 2.1 below.

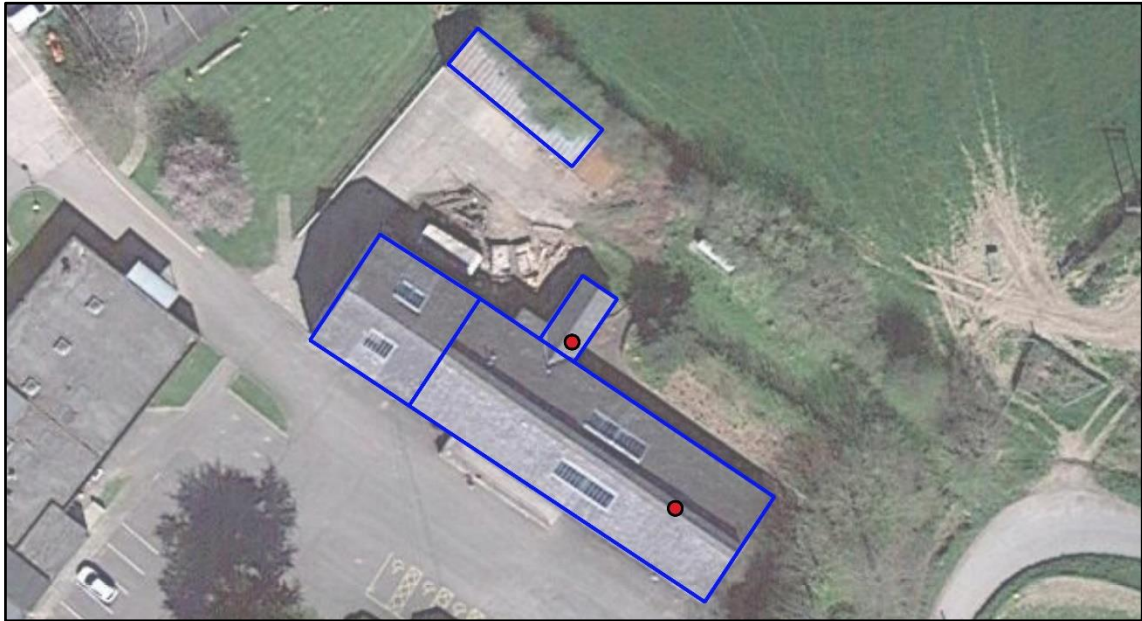
FIGURE 3.1. STATIC DETECTOR LOCATIONS INDICATED BY THE RED SPOTS. BASE IMAGE ©GOOGLE 2024

- 3.4.1 An Anabat Swift detector was left within the roof void of the outbuilding of the Learning Resource Centre from 20/06/24 - 01/07/24, and an Anabat Express within the roof space of the Library building section from 20/06/24 - 11/07/24, which recorded activity within these spaces (see Figure 3.1 for detector locations).

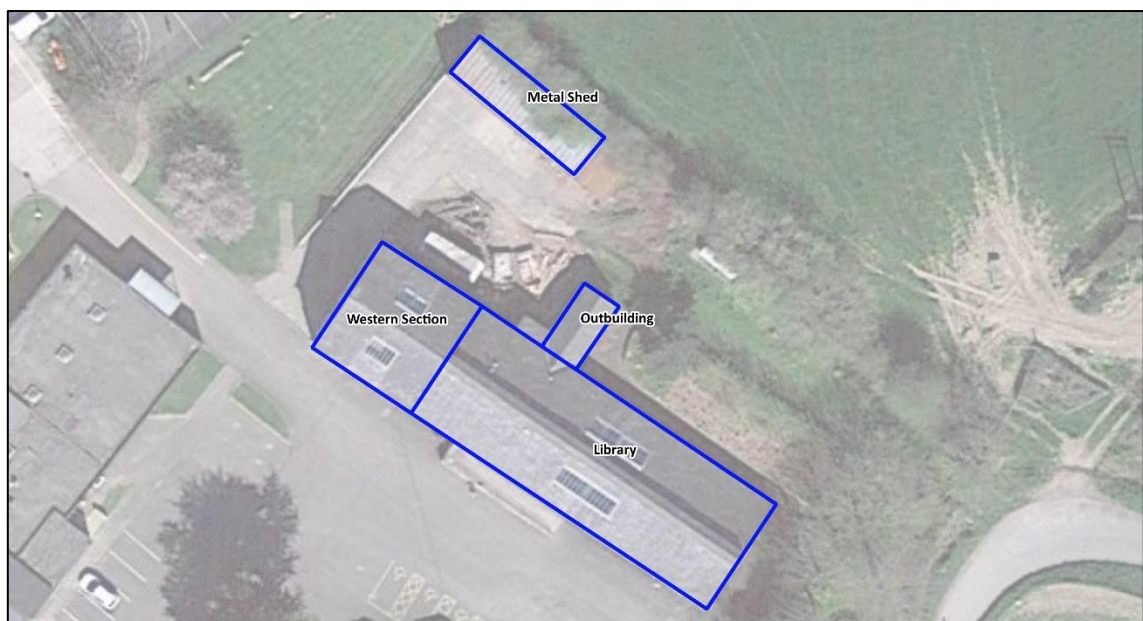
FIGURE 4.1. BASIC PLAN OF SITE BASE IMAGE ©GOOGLE 2024

- 4.1 The buildings comprised a large shed (open on the southern side) with corrugated metal sides and roof, and the Learning Resource Centre, comprised a three-storey section on the western elevation, a long single storey section on the eastern elevation and a small single storey outbuilding on the northern elevation.

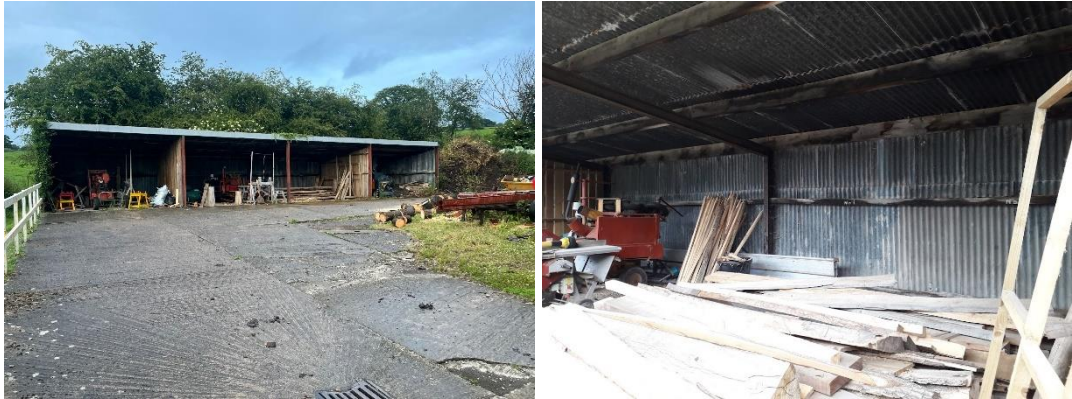
Description	Photo
Metal Shed	
<ul style="list-style-type: none"> • Metal frame with single skin corrugated metal sides and roof. • Two internal dividing walls, creating three separate areas. • Open on the southern side. • Used for storage of materials and machinery.

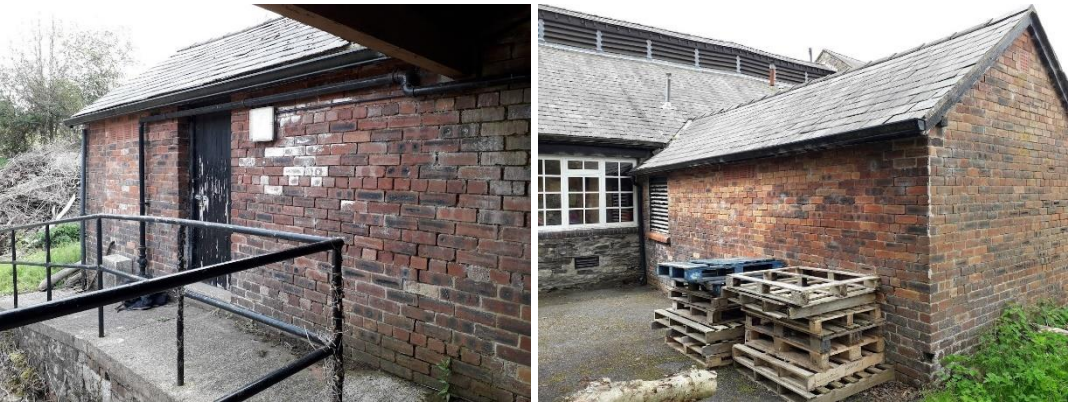
Outbuilding, Learning Resources Centre	
<ul style="list-style-type: none"> • Single storey, brick built outbuilding, on the northern elevation of the Learning Resource Centre. • Slated roof, with bare slates and a wooden frame. No fascias or soffits at the eaves. • There was a ceiling within the building, creating a roof void, accessible (for bats) through a hole approx. 30x30cm at the southern side. • During the PRA, the door on the western elevation was open.

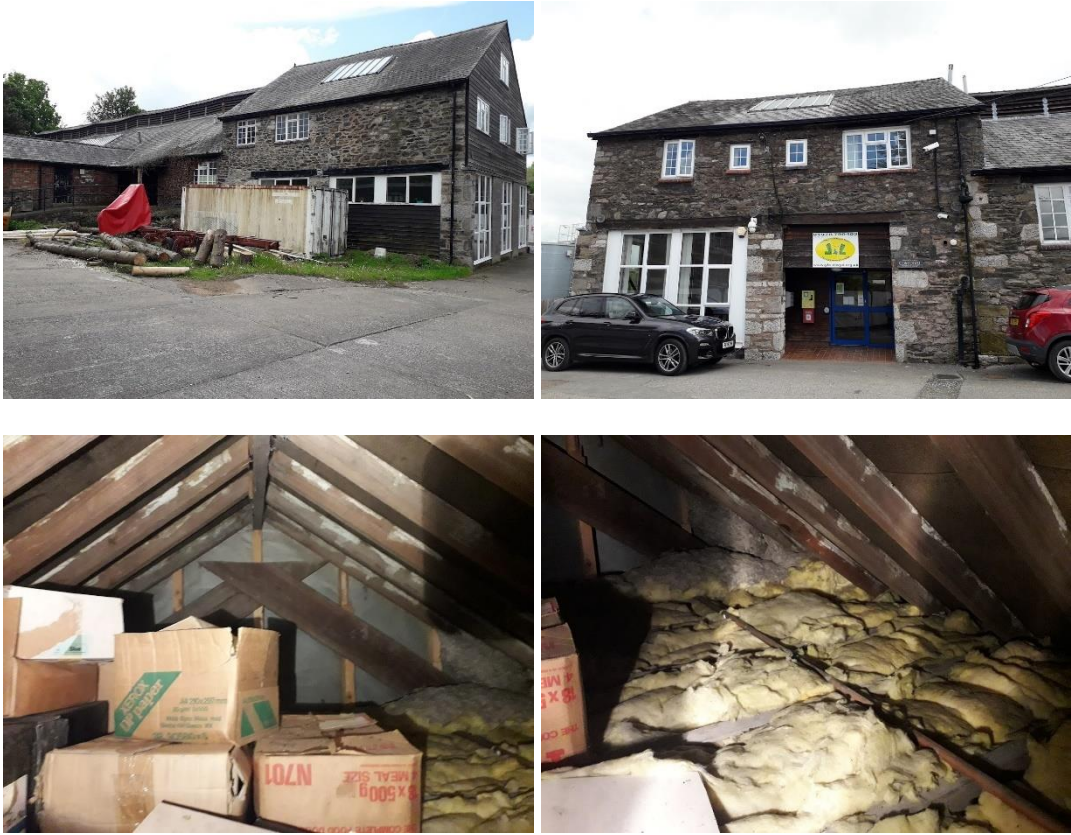
Description	Photo
Western Section, Learning Resources Centre	
<ul style="list-style-type: none">• Three storey stone-built building, with a slated roof.• Western gable end was clad with wooden panelling.• The main area of the roof had been converted into a classroom with a vaulted ceiling.• There was a small loft space (105cm high to ridge), which comprised wooden beams, bitumen roof lining and insulation.

<p>The photo section contains four images. The top-left image shows the exterior of the three-story stone building from a side angle, with a red tarp and a white container in the foreground. The top-right image shows the front entrance of the building, featuring a blue door and a sign above it, with a black car parked in front. The bottom-left image shows the interior of a small loft space with wooden beams and several cardboard boxes. The bottom-right image shows a close-up of yellow insulation material installed between wooden roof beams.</p>

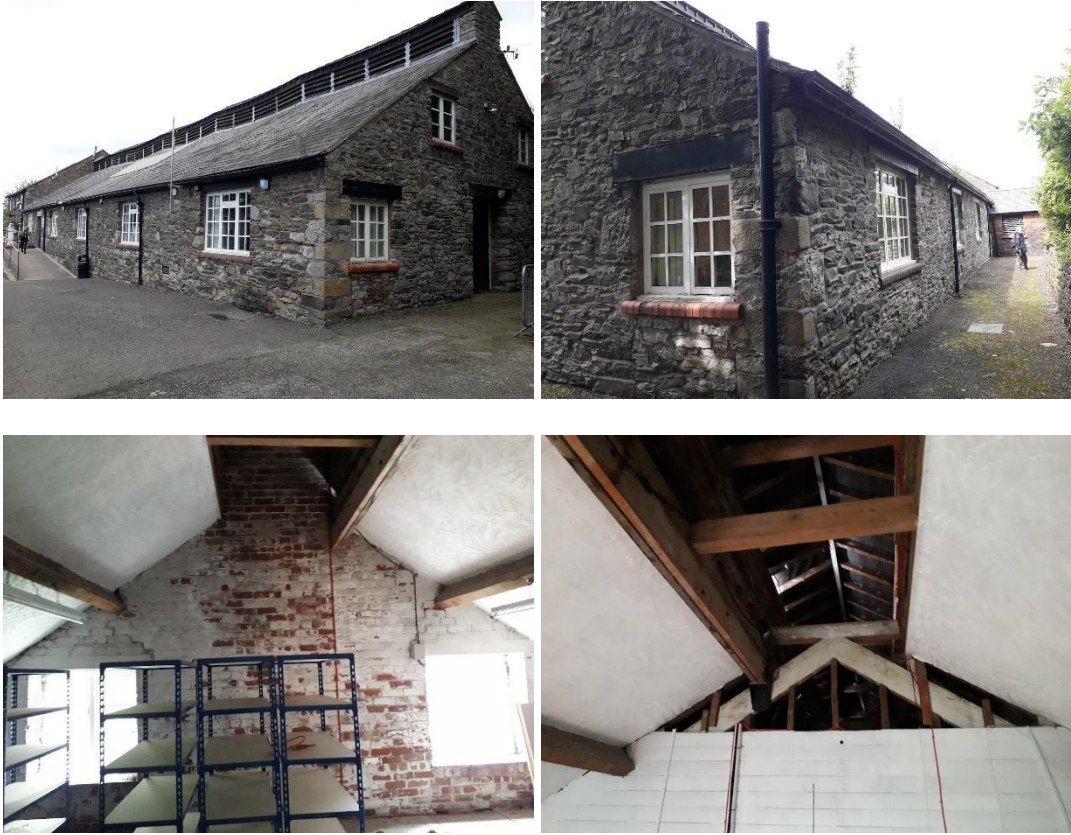
Description	Photo
Library, Learning Resources Centre	
<ul style="list-style-type: none">• Stone built, single storey building.• Slated roof, with large wooden vents at the apex (many blocked), running the length of the building.• Large roof space with the only accessible part, at the eastern gable end. This section of loft had been converted and had two windows in the gable end wall that provided a lot of light into the room.

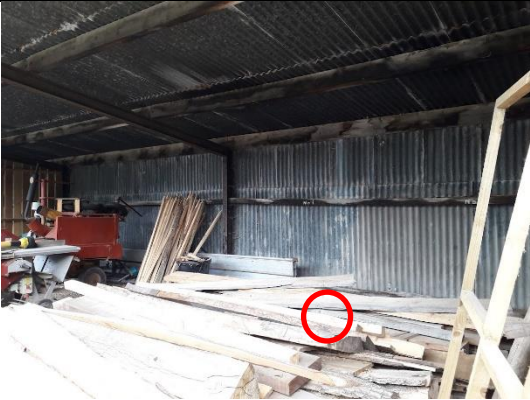
Description	Example Photos
Metal Shed	
<ul style="list-style-type: none"> The shed was open on the southern elevation, with no dark areas. A small number of droppings consistent with brown long-eared bats, were found on top of some stored wood, underneath a beam.

10.4.1 The shed had negligible potential as a day roost, as it was open on one side, with no darker areas. However, a small number of droppings, consistent with brown long-eared, were found on top of some stored materials during the PRA, which shows it was used as a feeding perch/night roost by this species.

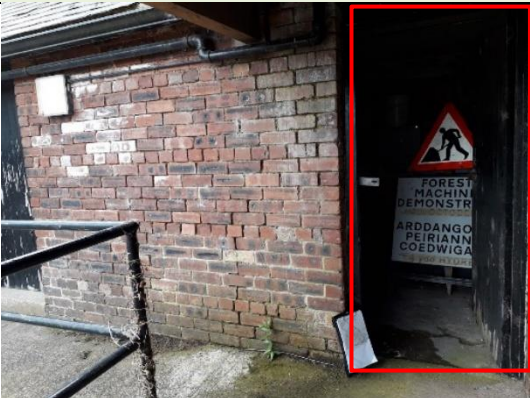
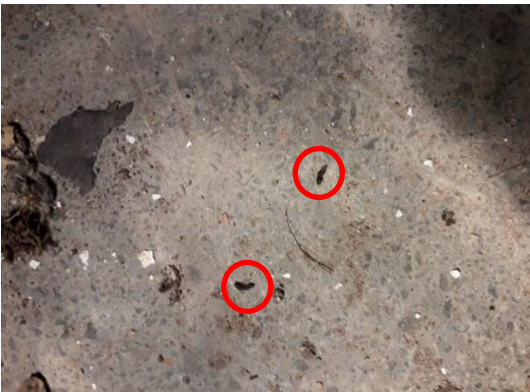
Outbuilding, Learning Resources Centre	
<ul style="list-style-type: none"> At the time of the PRA, the door on the western elevation was open, providing access for bats. A large hole in the ceiling led to the roof void above. Number of gaps present where the outbuilding attached to the Library Section, so would be possible for bats to move between them. Many gaps present at the eaves. Droppings consistent with lesser horseshoe, were present on the floor of the outbuilding.

10.5.1 During the PRA, droppings consistent with LHS, were found scattered on the ground floor. There was access for bats into the roof void through the open door and up through a hole in the ceiling, along with other potential roosting features.

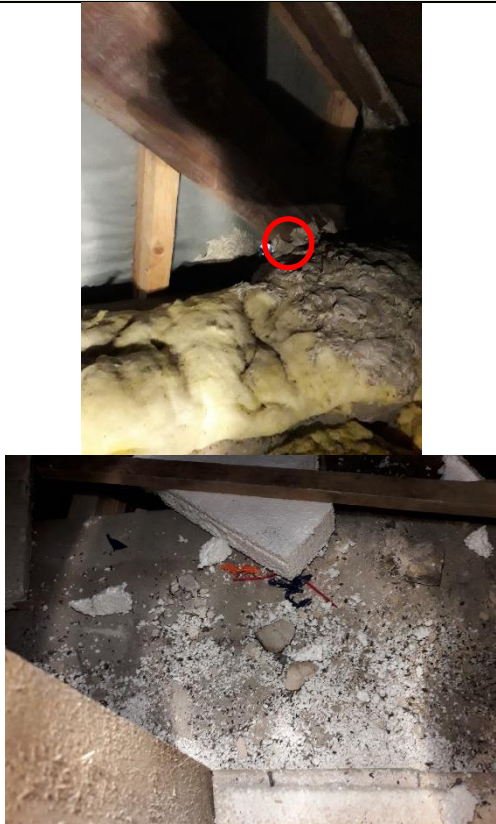
Western Section, Learning Resources Centre	
<ul style="list-style-type: none">• There was a hole in the gable end wall that attached to the library building which provided access into the library loft space, suggesting bats could have access between the two buildings.• Small hole where a pipe exited at the western gable end.• Droppings consistent with pipistrelle <i>sp.</i> within the roof space.

10.6.1 During the PRA, a number of access points and potential roosting features were identified and droppings consistent with pipistrelle species, were found scattered throughout.

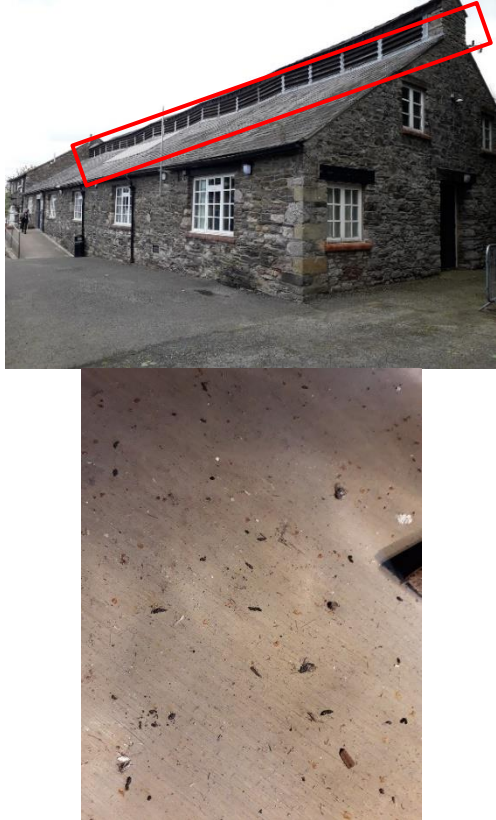
Library, Learning Resources Centre	
<ul style="list-style-type: none">• Large vents ran along the length of the apex of the library section.• Loft space significantly darker than the converted section at the eastern gable end. Vents were largely blocked, but there was still access via gaps underneath the bottom wooden vent panel• Some gaps above the wall and below the rafters, seen externally.• Small number of bat droppings on the floor of the accessible area at the eastern gable end of the building, concentrated under the central roof beam.• Birds next above light fitting on southern elevation.

10.8.1 The buildings were found to be suitable for use by nesting birds and a nest was identified above a light fitting on the southern elevation of the library building. There were potential areas for nesting both internally and externally within the cracks in the walls and various crevices.

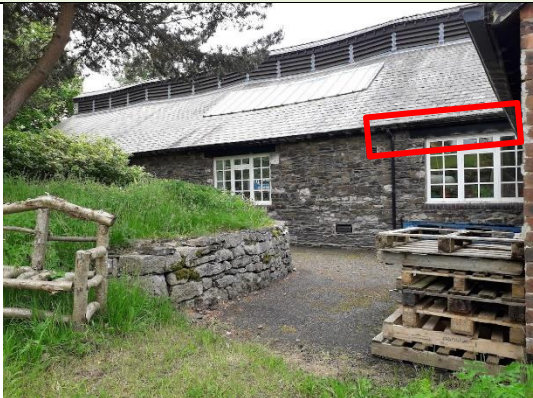
Emergences			
Time	Species	Emergence Location	Photo
21:27 & 21:31	2x common pipistrelle	From under soffit on the northern elevation of the Library building, to the east of the outbuilding.

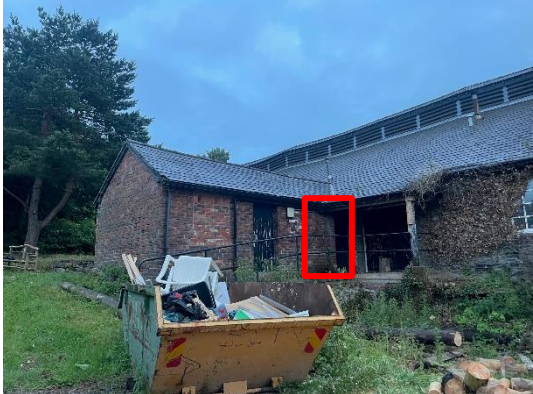
22:30 to 22:34	1x lesser horseshoe	Flying in and out of the outbuilding doorway

10.5.2 During the first emergence survey, a single LHS was seen flying in and out of the outbuilding doorway. The doorway had been closed prior to the second emergence survey.

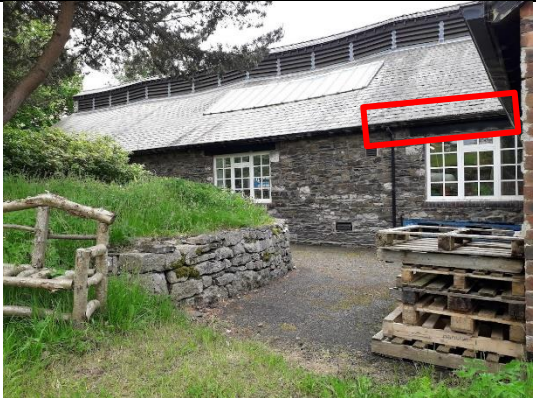
Emergences			
Time	Species	Emergence Location	Photo
21:48 & 21:57	2x common pipistrelle	From under soffit on the northern elevation of the Library building, to the east of the outbuilding.
